Swan Lagoon

This report card summarises the current state of knowledge of physical, chemical and biological characteristics of Swan Lagoon based on the knowledge gained from investigation and monitoring conducted by the Department of Water through the South Coast Wetland Monitoring Program.

About Swan Lagoon

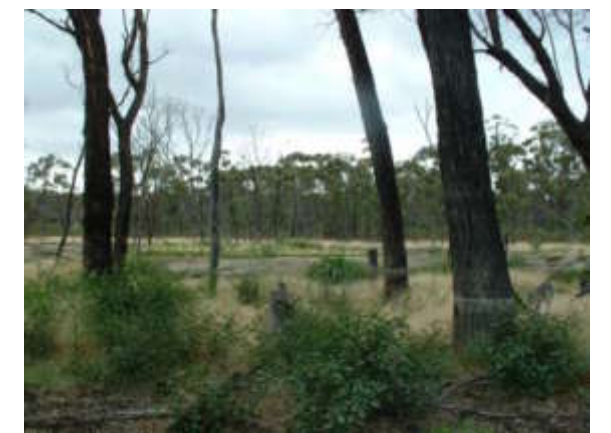
Vegetation predominantly consists of *Eucalyptus occidentalis* (Yates) throughout the wetland, with regenerating Yate trees in the midstorey and *Juncus pallidus* in the understorey. There is a large amount of woody debris in the wetland including a few collapsed trees.

Eucalyptus occidentalis (Yates) and regenerating trees in Swan Lagoon (note the high water line on the trunks)

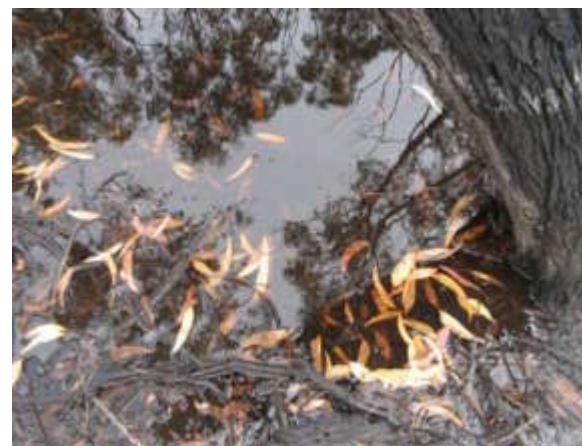
Low proportions of available nitrogen can indicate the majority is being readily taken up by plants and animals while the remainder may be bound up in organic matter, or as dirt or dead cells.

Large amounts of organic material in Swan Lagoon

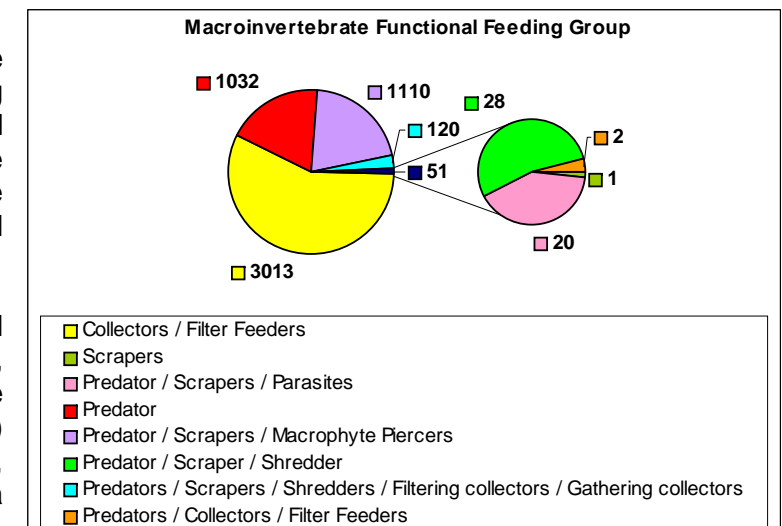
Each group of Macroinvertebrate play a different role in the food chain, some feed on organic material (Shredders), others feed on fine organic particles (Collectors/filter feeders), others graze on algae (Scrapers), some feed on each other (Predators), others are parasitic (Parasites) and some are Macrophyte piercers that feed off living plants and algae fluids. These groups are called Functional Feeding Groups (FFG). Some Macroinvertebrates fit into more than one of these groups, for example the Water Boatman is a Predator, a Scraper and a Macrophyte piercer.

A healthy wetland should have a representative of each functional feeding group. A loss or dominance in a particular group may indicate a change in ecology of the wetland. The composition of these groups at Swan Lagoon are displayed in the below graph.

There appears to be a high number of collectors / filter feeders which could relate to high amount of suspended decomposing fine particulate organic matter in the wetland. The high number of Macrophyte Piercers may be due to the large amount of organic matter on the floor of the wetland from the *Eucalyptus occidentalis* (Yates).
