# Lake Matilda

This report card summarises the Department of Water's current state of knowledge of the physical, chemical and biological characteristics of Lake Matilda based on the knowledge gained from investigation and monitoring conducted by the Department of Water through the South Coast Wetland Monitoring Program.

South Coast Wetland Monitoring Project

June 2008

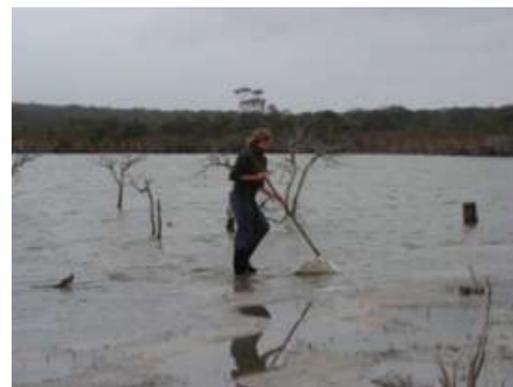
Sweeping for macroinvertebrates

Nineteen groups of macroinvertebrates were found at Lake Matilda during the monitoring period of which the most abundant included; Cladocera (water fleas), Ostracoda (seed shrimp), Copepoda (copepods), Amphipoda (scuds), Gastropoda (snails/limpets), Zygoptera (damselflies), and Notonectidae (backswimmers).

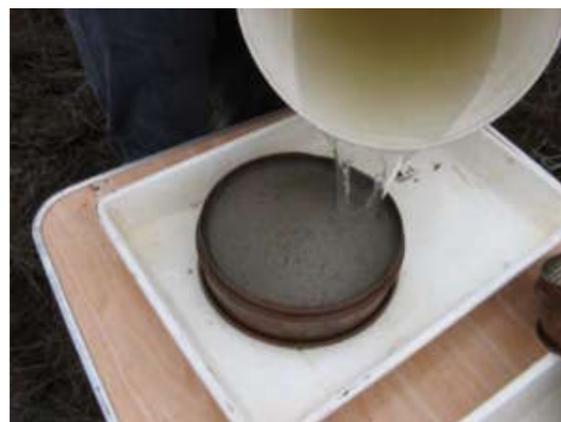
Washing macroinvertebrates into tray for identification

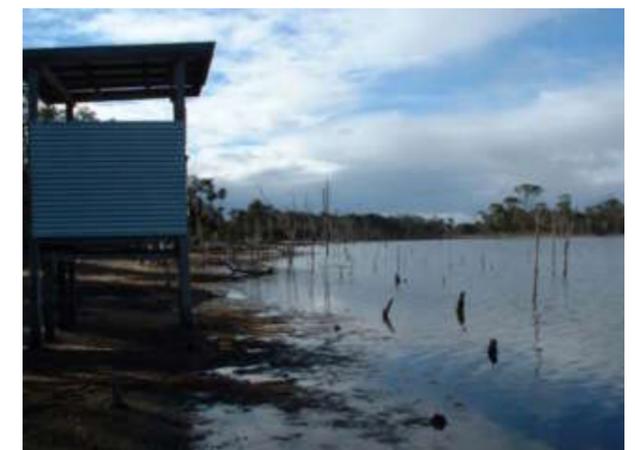
Bird hide on the edge Lake Matilda with riparian vegetation in the background

Vegetation in the upper storey consists of Yate trees, *Melaleuca cuticularis* (Saltwater paperbark) and Jam Trees (Bush Tucker) with Samphires (Salt Bush) in the under storey. There are a number of dead trees in the wetland with some regeneration occurring around the margins. A bird hide is situated on the edge of the lake.

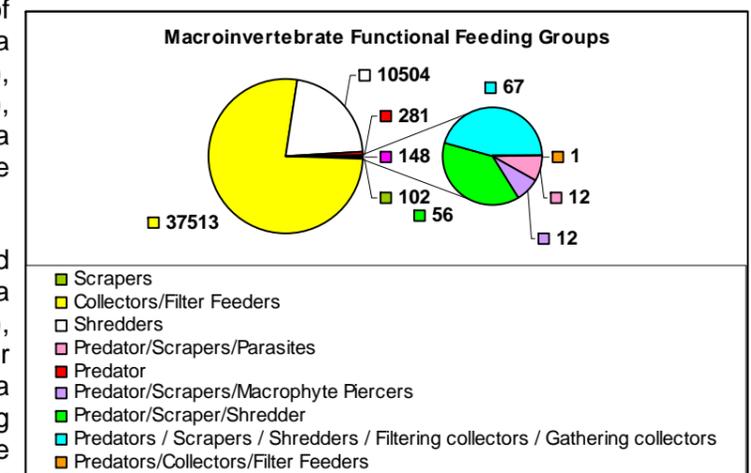
A healthy wetland should have a representative of each functional feeding group. A loss or dominance in a particular group may indicate a change in ecology of the wetland. The composition of these groups at Lake Matilda are displayed in the below graph.

Each group of Macroinvertebrate play a different role in the food chain, some feed on organic material (Shredders), others feed on fine organic particles (Collectors/filter feeders), others graze on algae (Scrapers), some feed on each other (Predators), others are parasitic (Parasites) and some are Macrophyte piercers that feed off living plants and algae fluids. These groups are called Functional Feeding Groups (FFG). Some Macroinvertebrates fit into more than one of these groups, for example the Water Boatman is a Predator, a Scraper and a Macrophyte piercer.
